# URGENT MEDICAL DEVICE CORRECTION

Baxter is issuing an Urgent Medical Device Correction for the **Novum IQ** large volume pump (LVP) due to the following two issues:

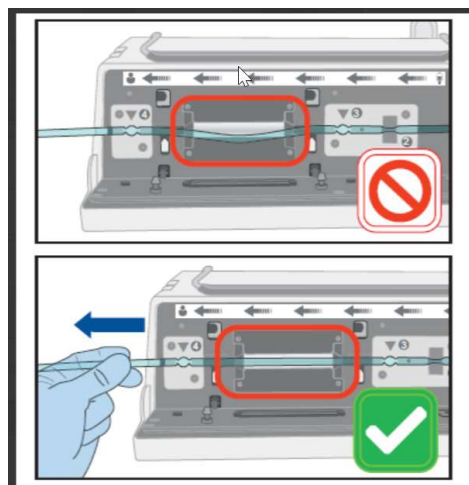
- 2) Baxter has identified an increase in customer reports of over and underinfusion that may be due to set misloading. Failure to properly load the tubing into the pump channel may result in the pump infusing at a rate higher or lower than programmed. Consistent with the instructions for use, customers should ensure that:
  - a) The door is fully open before loading the set as pictured on page 5 of enclosed Attachment A.
  - b) The tubing is taut and loaded without slack in the pumping channel as pictured on page 7 of enclosed Attachment A, and in Figure 1 below.

With respect to the first issue (flow rate change), this may lead to the pump delivering at a lower rate than intended (underinfusion). With respect to the second issue (set misloading), this may lead to non-delivery, underinfusion, or overinfusion of the intended solution/medication.

Baxter is developing a hardware change to reduce misloading of the set and will contact customers to update the pumps when the correction is available.

3. To prevent misloading, please follow the instructions for loading the set in section 4.3, Loading an Administration Set, of the **Novum IQ** LVP Operator's Manual (refer to enclosed Attachment A).
